Case Report

Drill bit failure in Mandible fracture Fixation- A case report and Management

From, Chief Civil Surgeon, Department of Plastic Surgery, Government District Headquarters Hospital, Kumbakonam, Tamilnadu, India

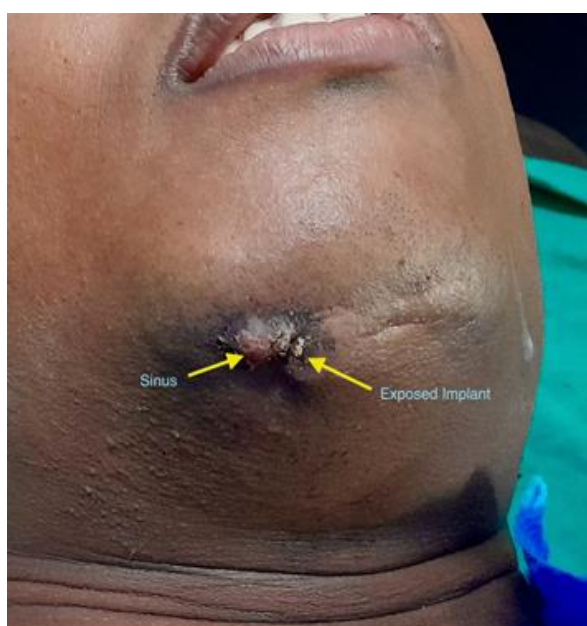
After 12 months, the patient developed swelling, pain, and serous discharge following a trivial trauma and returned to India for consultation. The patient was well nourished and without any comorbid conditions. Examination revealed a swelling in the chin with a discharging sinus exposing the tip of the implant, but without signs of infection (Figure 2). The intraoral examination revealed the mandible to be firm and indurated, without any visible signs of inflammation or

Figure 2: Presentation with sinus and exposed implant
